DEFENSE ATOMIC SUPPORT AGENCY WASHING
BIKINI SCIENTIFIC RESURVEY. VOLUME II
DEC 47

Bikini Scientific Resurvey, Annex I

SARATOGA: GENERAL DESCRIPTION OF DAMAGE

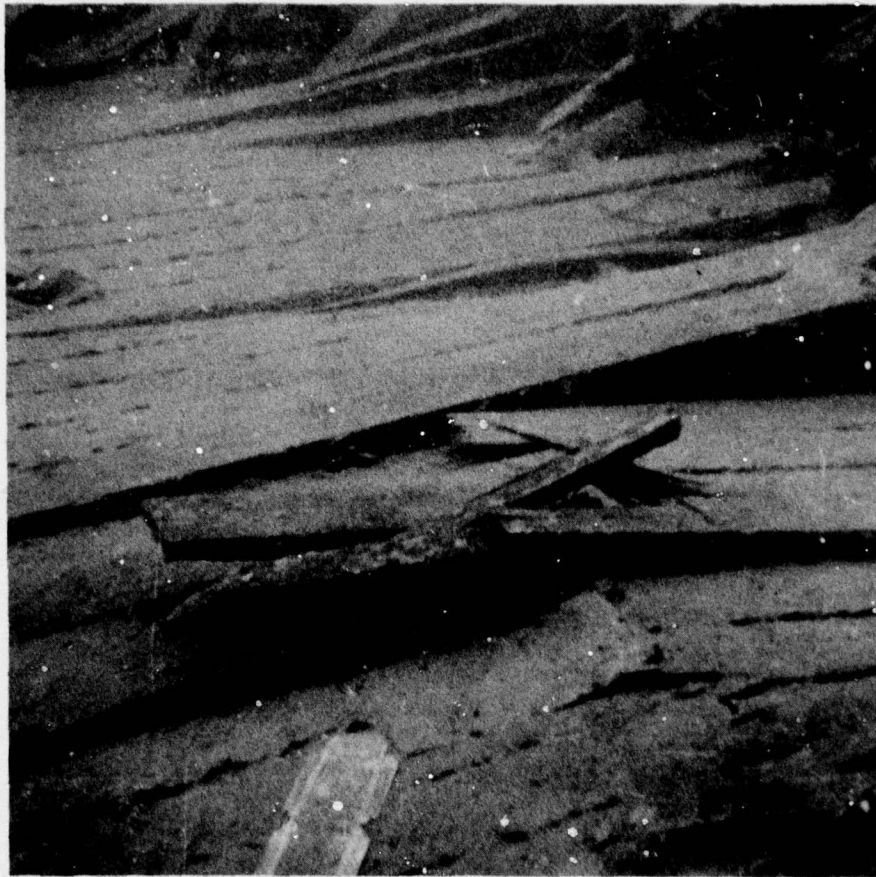
#8 of a series of photographs of damaged flight deck near centerline about frame 168. ABCR Photo No. 6027-11.

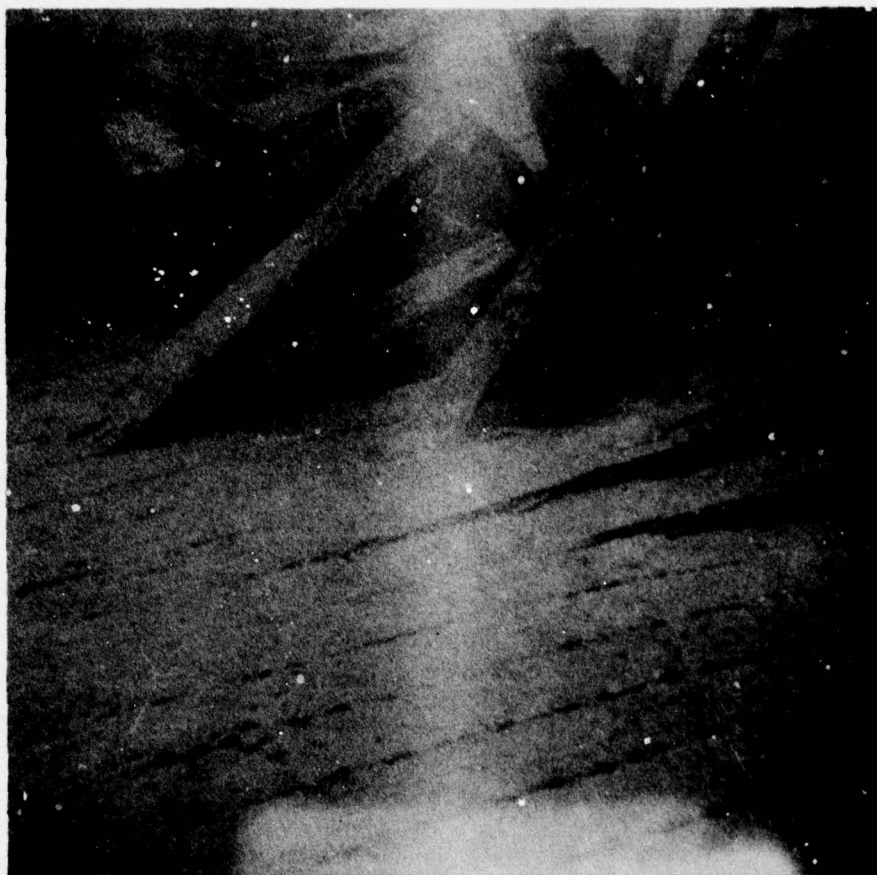
#9 of a series of photographs of damaged flight deck near centerline about frame 165. ABCR Photo No. 6027-12.

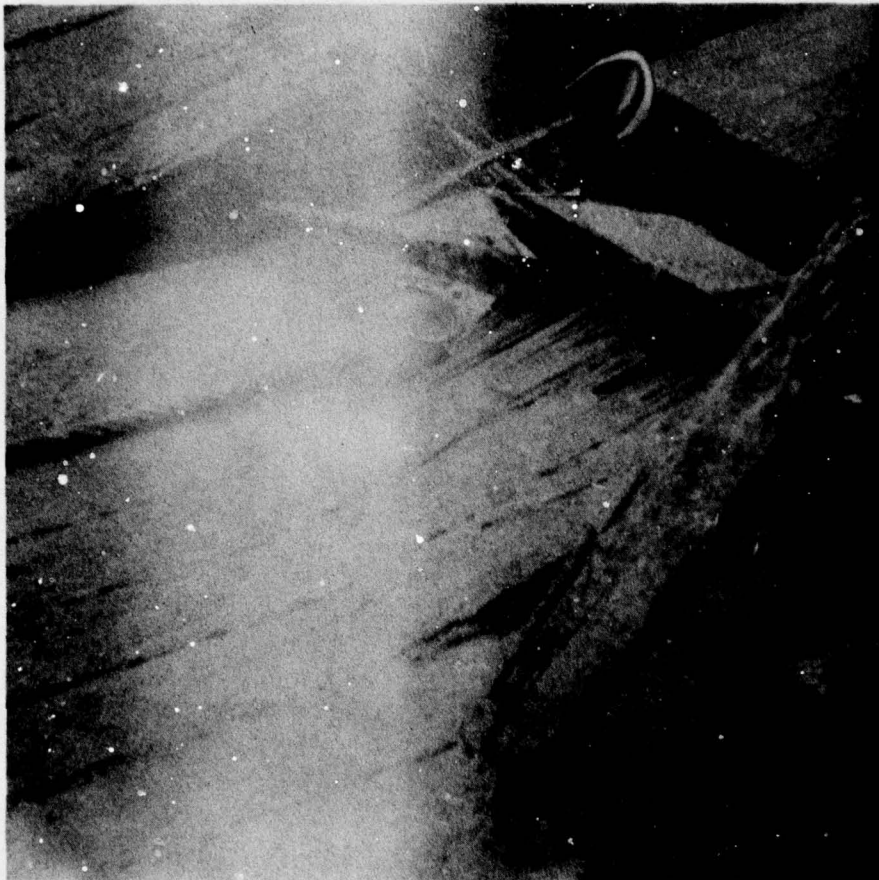
#10 of a series of photographs of damaged flight deck near centerline about frame 162. ABCR Photo No. 6027-13.

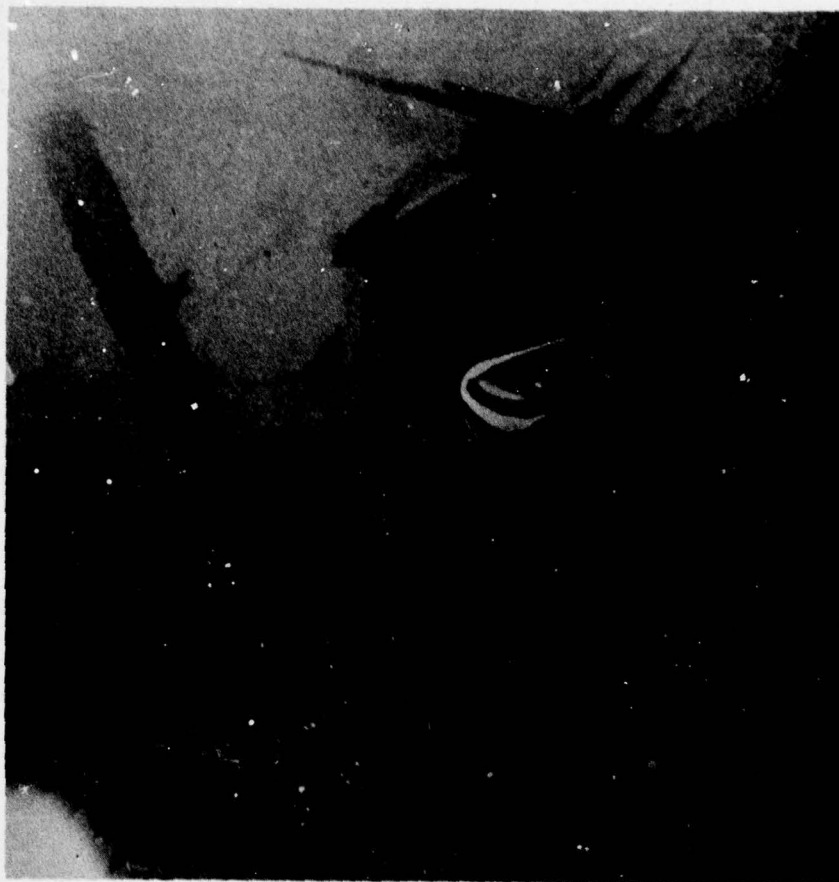
#11 of a series of photographs of damaged flight deck near centerline about frame 160. ABCR Photo No. 6027-14. END.

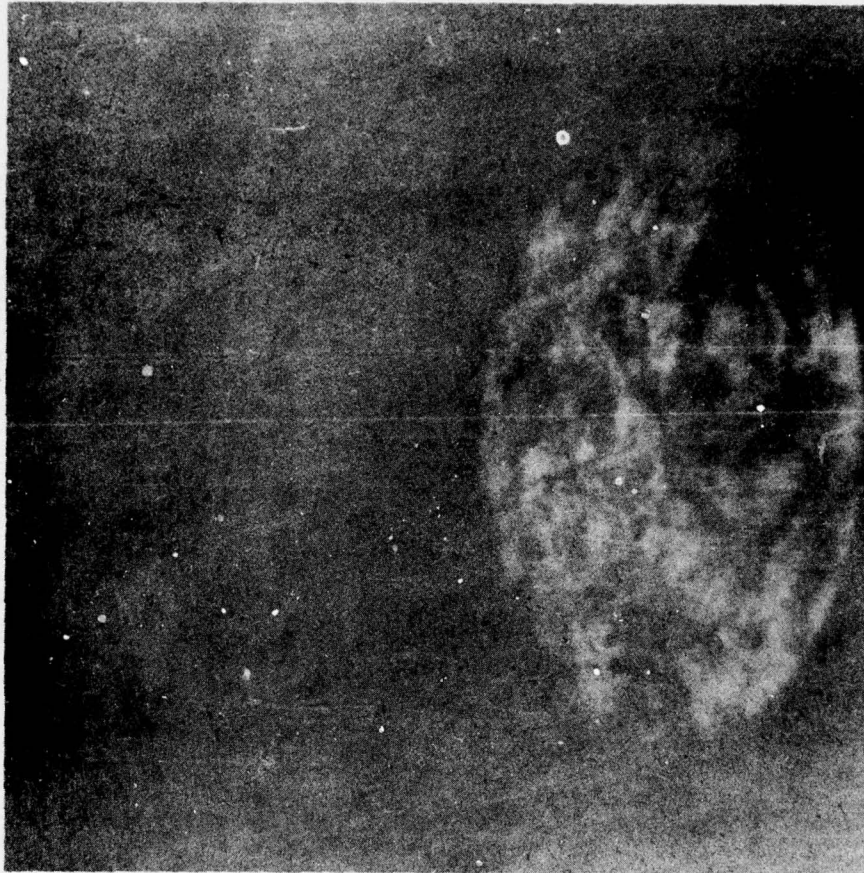
#1 of a series of photographs of crack in side of ship, about frame 192 starboard side below flight deck in way of break in flight deck. ABCR Photo No. 6029-2.
